Inspection Report
Minerals Regulatory Program
August 16, 2005

Mine Name: Bald Knoll
Operator Name: MMG Mining

Permit number: S/025/012
Inspection Date: August 3, 2005
Time:

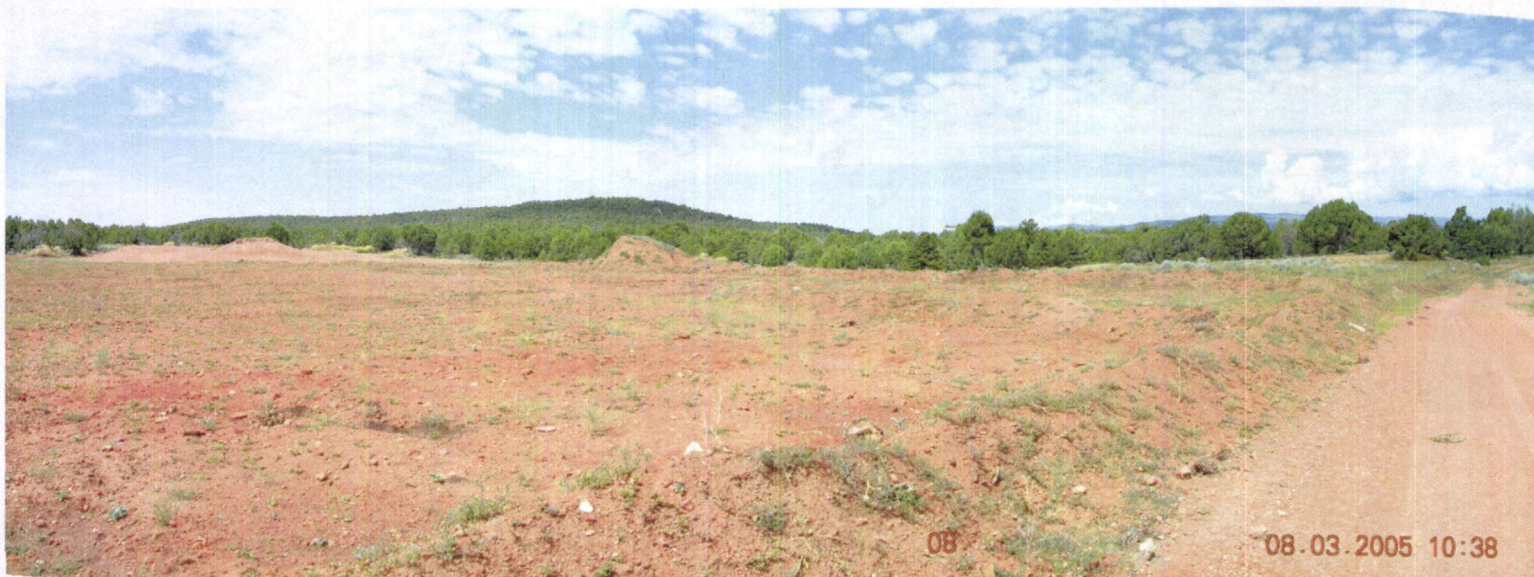
②

A total of 2.16 acres, of the 3.26 acre area committed to be reclaimed as a part of the Division Directive, has been reclaimed on the northern edge of the present pit. A portion of this 3.26 acre area, that was committed to be reclaimed, is still being used to support the present operation.

Bald Knoll
2.11 Ac. reclaimed
area.

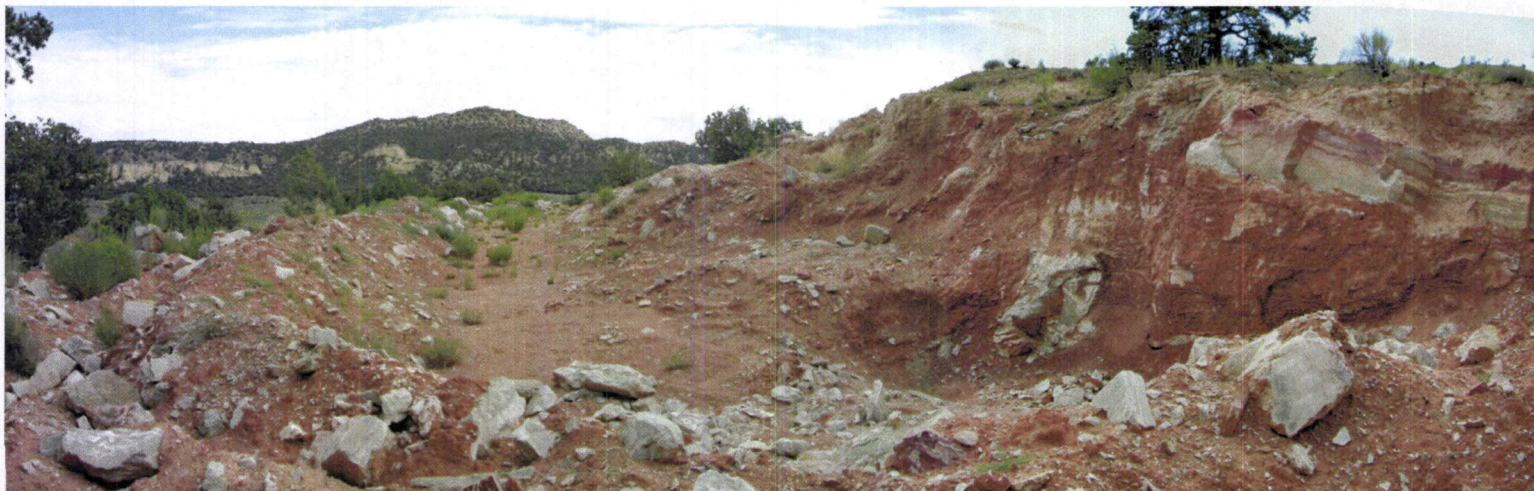
The mine is presently permitted and bonded for 4.3 acres of disturbance. Due to the additional acres of disturbance, this site is presently in non-compliance. A LMO-NOI (large mine application) will need to be filled out and submitted to the Division.

③ Bald
disturbance in pit

In order to bring the site into compliance, the operator will need to apply for and obtain a NOI-LMO (large mine) permit from the Division. This large mine permit site will need to be obtained to allow for further mining activity.

A bond for all the acreage in excess of 4.3 acres of disturbance, which is presently permitted and bonded for, will need to be posted with Division.
